# HIGH VOLTAGE BREAKDOWN STUDY

#### ADDENDUM TO FINAL REPORT

ION PHYSICS CORPORATION
BURLINGTON, MASSACHUSETTS

**MARCH 1970**

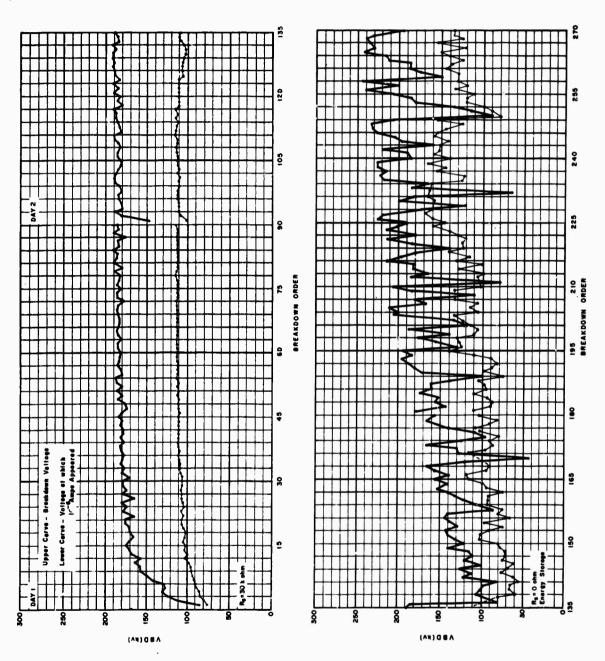
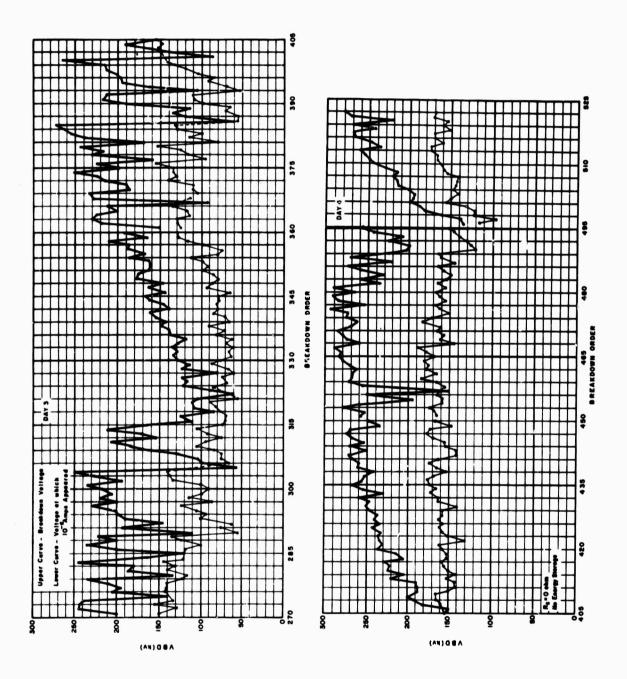
Conditioning Curve for 4-Inch Diameter Bruce Profile Electrodes --- Stainless Steel (304) Anode and Aluminum Cathode at .75 cm Gap. Figure 1.

Figure 1. Continued.

Anode	Cathode
Figure 1	304 Stainless Steel	Aluminum
Figure 2	Lead	Ti-7Al-4Mo
Figure 3	Molybdenum	Ti-7Al-4Mo
Figure 4	Tungsten	Ti-7Al-4Mo

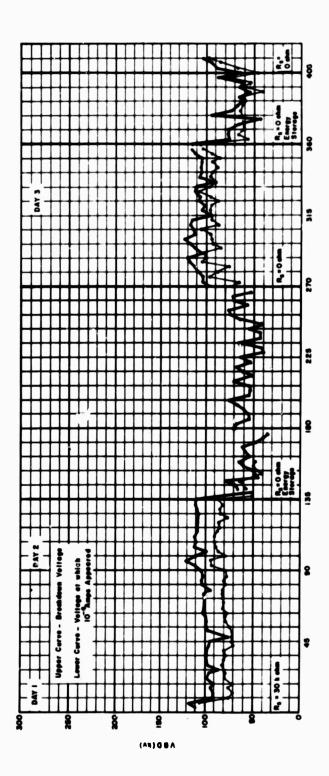
Conditioning Curve - 4-Inch Diameter Bruce Profile Electrodes Lead Anode and Ti-7Al - 4 Mo Cathode at .75 cm Gap. Figure 2.

The treatment with a lead anode had the predicted low level of maximum breakdown voltage. Additional tests with this electrode pair explored breakdown voltage as a function of gap from .25 to 4.5 cm. It was found that under low energy discharges the breakdown voltage at any gap in this range was well defined and repeatable. The dependence on the square root of the gap is given in Figure 6. As can be seen the fit is extremely good from 1.0 cm to 4.5 cm.

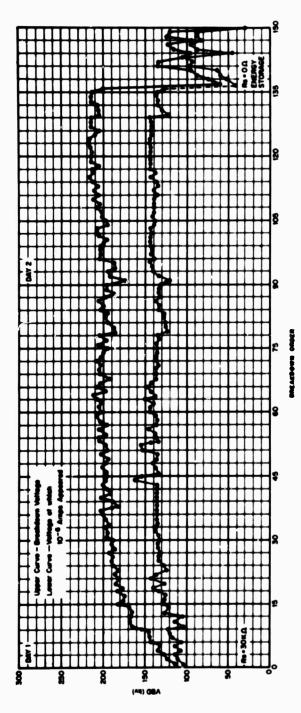
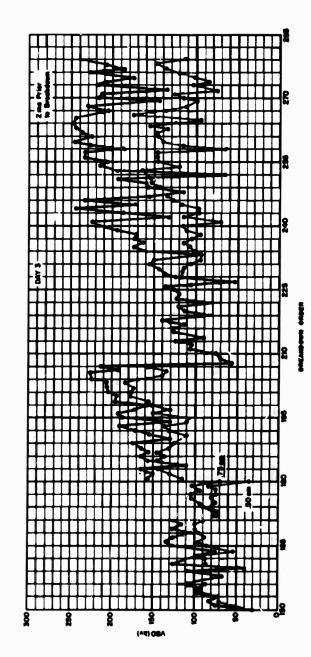
Conditioning Curve - Molybdemum Anode and Ti-7Al-4 Mo Cathode 2-Inches Diameter Uniform Field Electrodes at .75 cm Gap. Figure 3.

The treatments with Molybdenum and Tungsten anodes used disks of the metal 0.25 inches thick mounted on stainless steel electrodes. The edges were radiused so that a uniform field would result in the gap. These were used due to unavailiability of larger sizes of molybdenum and tungsten. The predicted maximum breakdown voltage for these metals was somewhat higher than was actually obtained (see Section 10.9). This disparity is thought to be due to long

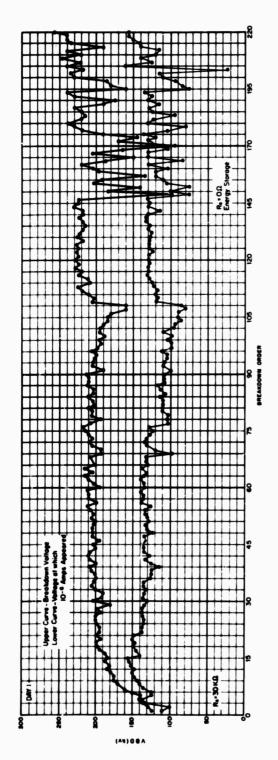
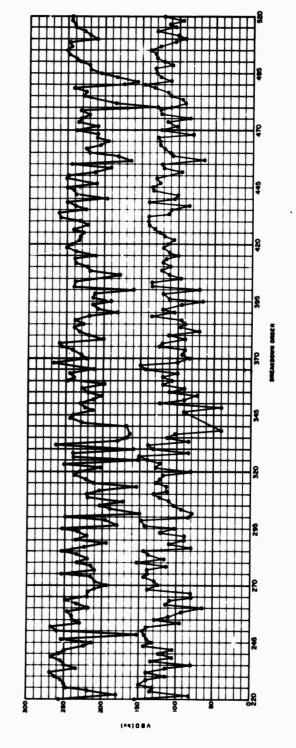
Conditioning Curve - Tungsten Anode and Ti - 7Al - 4 Mo Cathode 2-Inches Diameter Uniform Field Electrodes at .75 cm Gap.

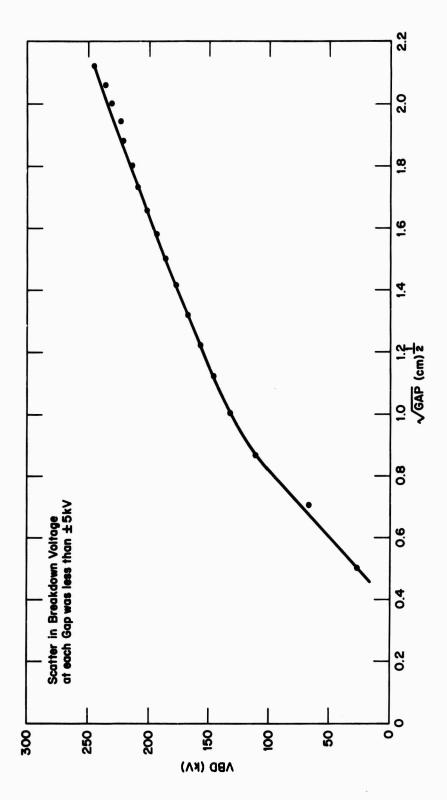
Breakdown Voltage versus Square Root of the Gap - 4-Inches Diameter Bruce Profile Electrodes - Lead Anode and Ti - 7 Al - 4 Mo Cathode - After Conditioning - Low Energy Discharges - Points are the Average of Nine Breakdowns. Figure 6.

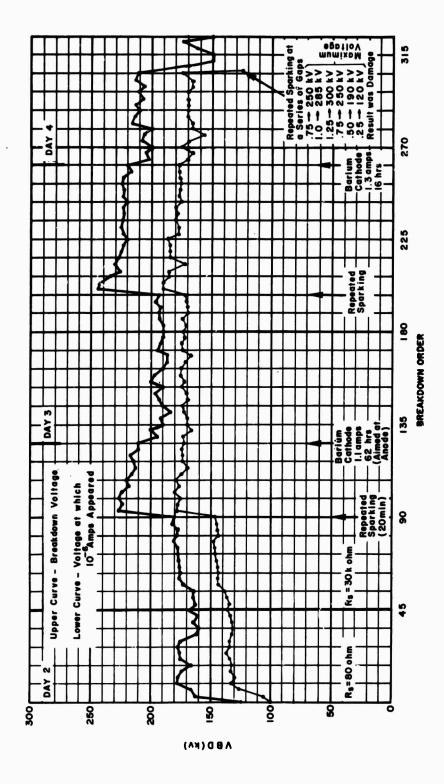
Conditioning Curve - 4-Inches Diameter Bruce Profile Electrodes Anode and Cathode OFHC Copper - Barium Contamination of Anode - Leak During Bake. Figure 7.

Detailed results of treatments discussed in Section II of the Final report are presented in Figures 7 through 9.

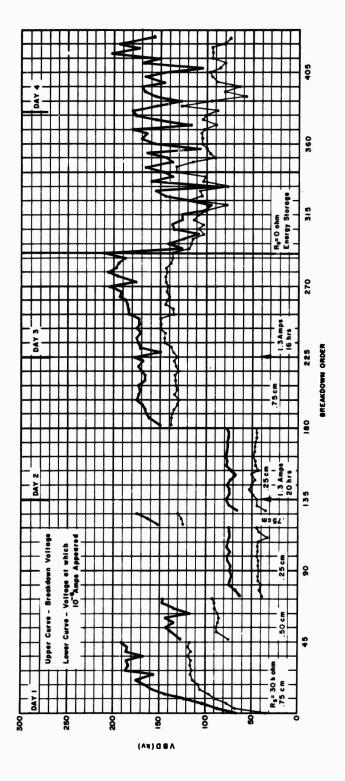
Conditioning Curve - 4-Inches Diameter Bruce Profile Copper Electrodes . 25 and . 75 cm Gap - Barium Contamination of Cathode. Figure 8.

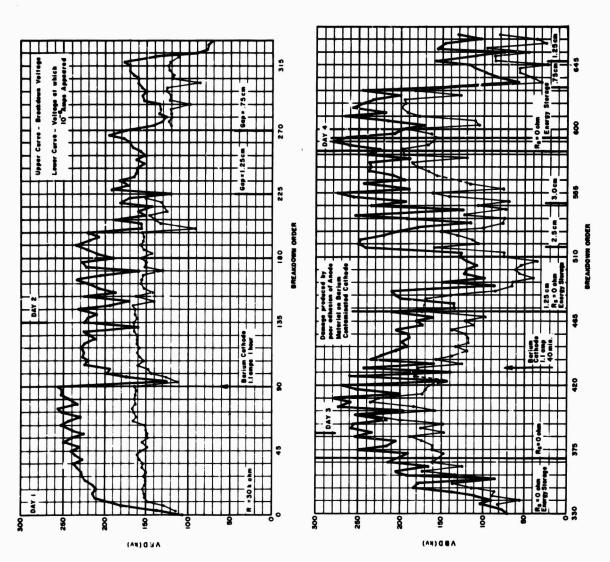
Conditioning Curve for 1.28-Inch Diameter Bruce Profile Electrodes of Nickel at .75 cm Gap with Heavy Barium Contamination of Cathode (at 2 mm).
